Embury Beacon Camp

Earthworks of an Iron Age hillfort on the South West Coast Path, with what remains gradually being lost as it slips down the cliffside

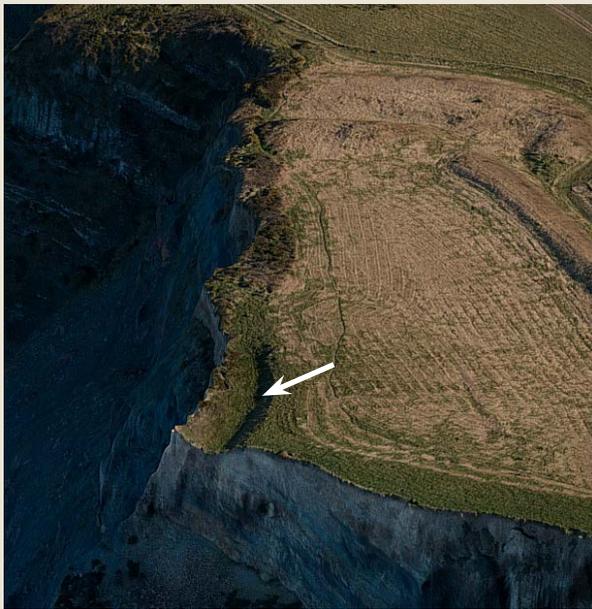
Remains of an internal rampart

A small section of rampart, shown as a bank and ditch, survives on the north-western cliff edge. The rest of this rampart has been eroded over thousands of years by coastal erosion, leaving little to tell us what the original size or shape of the area it enclosed would have been.

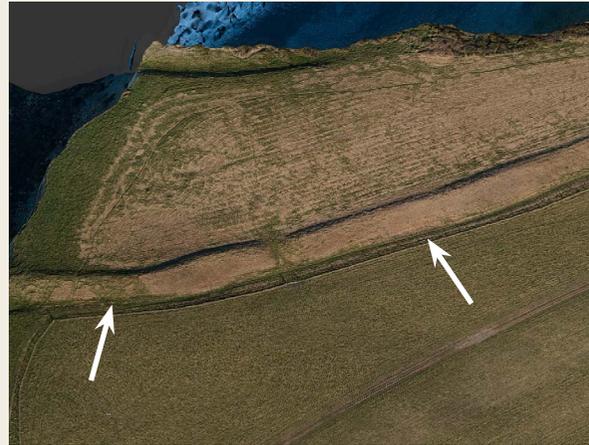
The external rampart (west)

The western end of the external rampart is the longest surviving section of rampart at the site, and is formed of a bank and external ditch. A gap in this part of the rampart is thought to be the result of the medieval or later use of the site, perhaps relating to access for grazing sheep within the enclosed space. This was later used to allow access along the former route of the South West Coast Path, although this has since been re-directed to minimise further rampart erosion.

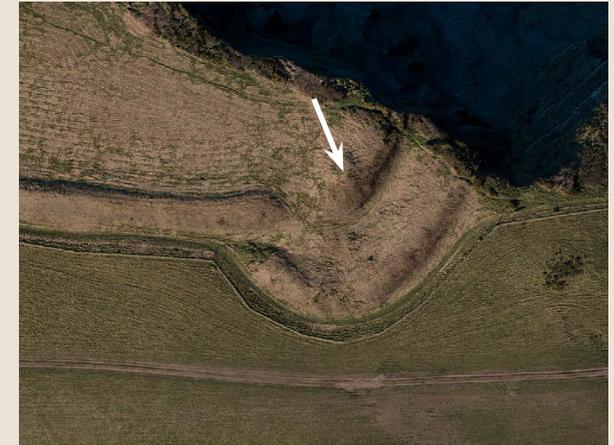
The external rampart (east)

Formed of a linear north-south bank and external ditch, the earthwork is slightly more spread and less uniform than the remainder of the rampart to the west. It may be the case this change in is the result of long-term weathering to the hillfort on its north-eastern side, or a result of a change (most likely later prehistoric) to the layout of the earthworks. This section of rampart is separated from the western section by an entrance gap.

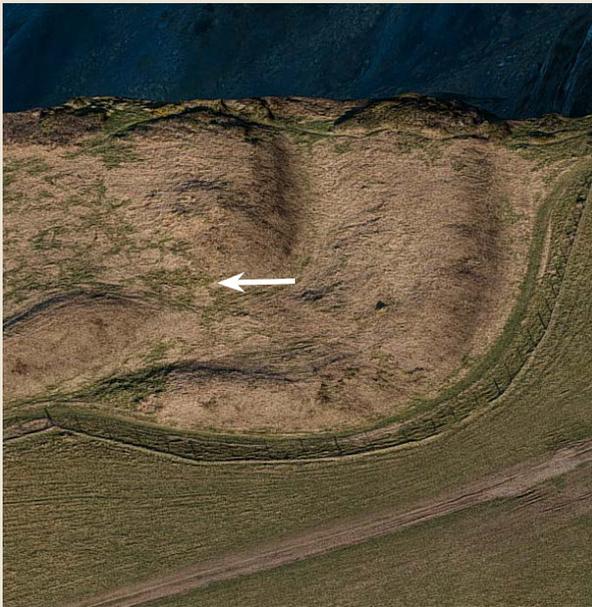
Hillfort entrance

The hillfort entrance is located at the north-western end of the site, and is approximately 6m wide. The entrance gap is enclosed by a further earthwork, or 'outwork' (see right) which was intended to prevent quick and easy access to the interior of the hillfort.

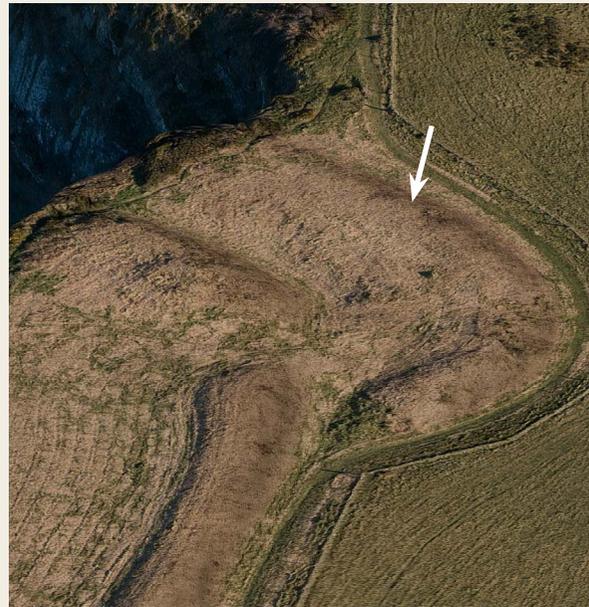
Outwork

The outwork rampart is formed of a section of bank on the eastern edge of the site, which curves around the external rampart at the location of the north-eastern entrance. The outwork would have acted as a barrier to prevent easy access to the hillfort entrance.

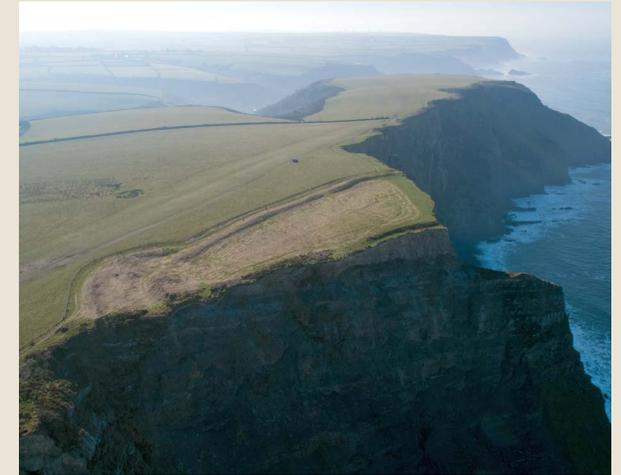
Coastal erosion

The earthworks at Embury Beacon Camp are being eroded away by the loss of the cliff edge and weathering. Historic maps and historic aerial photographs show little more than what the surviving earthworks show today, and the extent, shape, number of ramparts, and any unique features of this hillfort remain very much uncertain. It is possible that all of the earthworks will one day be lost as the coastline erodes away.
