Chapter Ten

RAF Northam

Category: Chain Home

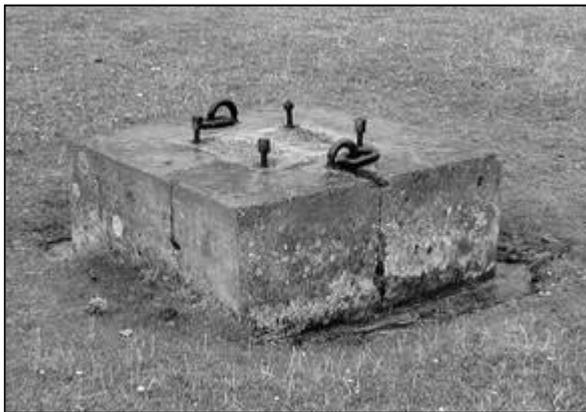
The concrete base of a transmitter mast.

On the Burrows the square, concrete bases of the two pairs of transmitter masts can be identified, together with sets of aerial halyard anchor blocks. Here too are aerial curtain balance weight bases and aerial halyard balance weights. By survey it was possible to define the footprint taken up by the transmitter masts and their anchors (see Appendix One).

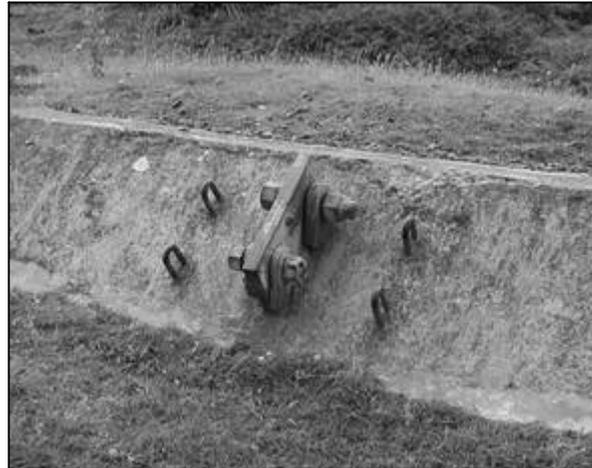
An aerial halyard anchor block. The illustration below (of a modern communications mast) demonstrates how halyards are anchored.

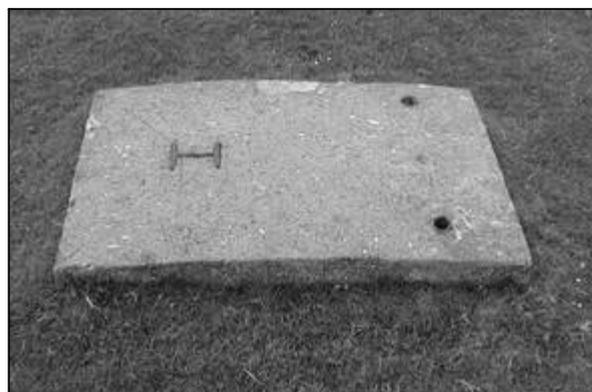
The base of an aerial curtain balance weight.

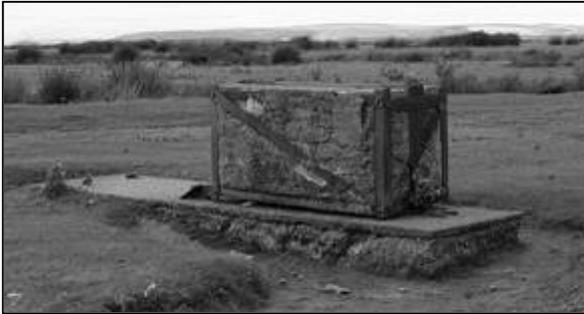
The remains of an aerial halyard balance weight.

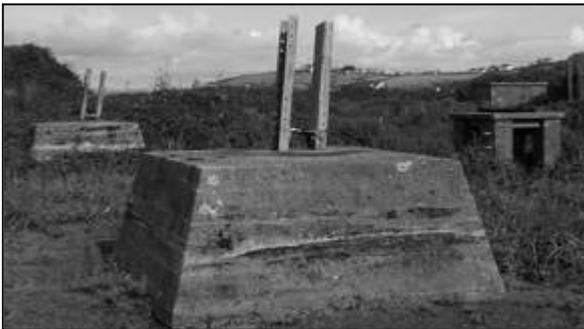
Metal struts to which a timber receiver tower was bolted still remain embedded in the concrete bases. An aerial cable junction box is on the right.

The boundaries of the remainder of the former site are marked by Sandymere Road, Appledore Road, Burrows Lane and the Burrows. Here concrete bases for timber receiving towers and their aerial cable junction boxes can be noted. Metal struts embedded in concrete bases, to which the timber tower "legs" were bolted, are still in place.

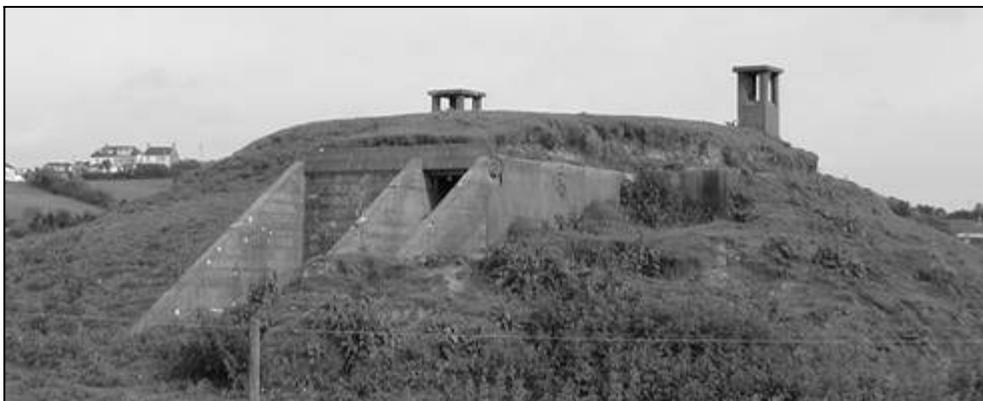
A transmitter block, adjacent to the Burrows.

Most of the structures and features on private land can be viewed from the public highway. A transmitter block, still with its earth covering, stands adjacent to Burrows Lane at a point where the road enters the Burrows.

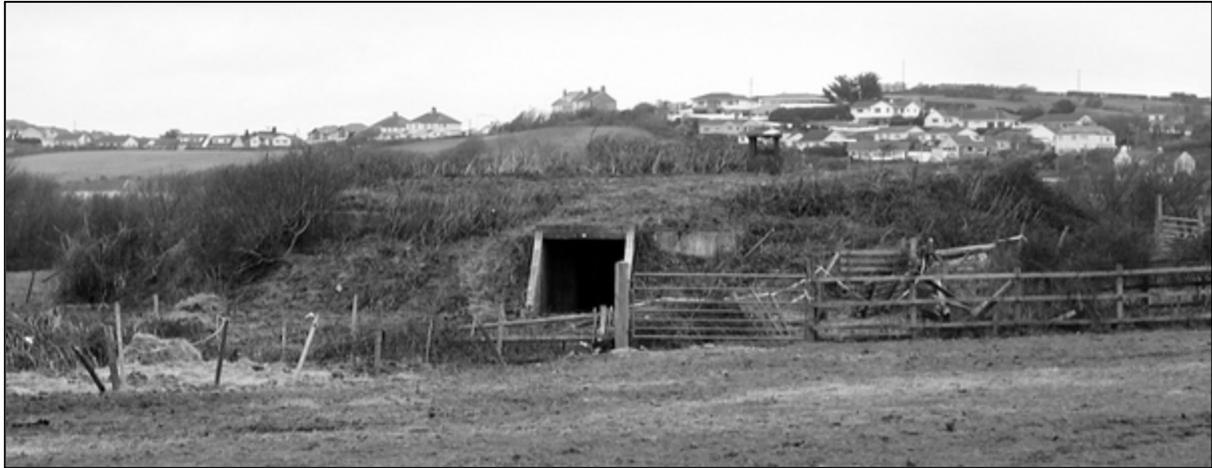
A receiver block.

Two receiver blocks are *in situ*. One is still earth-covered; the other has lost its earth protection, but this provides a helpful indication of the size of such a building and its construction (reinforced concrete, encased in a waterproof membrane). An archive photograph²⁵ confirms that the second transmitter block was constructed in the location proposed on Air Ministry drawings (on present-day private property), but this could not be identified from the road, and has perhaps been removed or converted, but what the Air Ministry plans describe as a sub-station is extant, albeit without its earth covering.

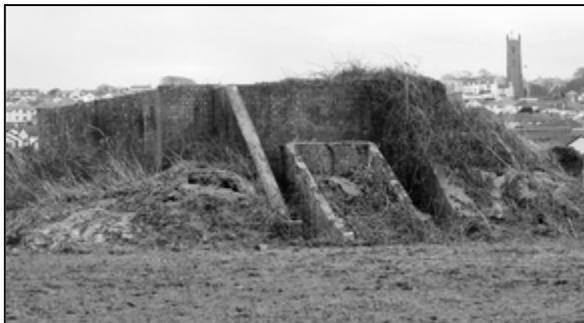
A putative ICH building with earth blast mound.

Both structures have a central concrete base, possibly foundations for a “temporary” building, such as a hut. These are surrounded by brick retaining or revetment walls associated with earth blast mounds. One building retains some earth, but this has been removed from the second. A concrete base abuts one structure, onto which are set two concrete plinths. A photograph in a local archive²⁸ shows that the plinths were housed within a substantial structure, which was possibly a generator house.

It is proposed that the buildings belong to an early phase in the development of the station and could have been ICH structures²⁹.

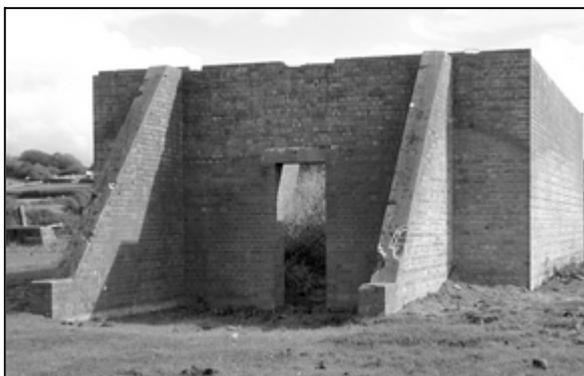
A putative ICH building with earth blast mound removed.

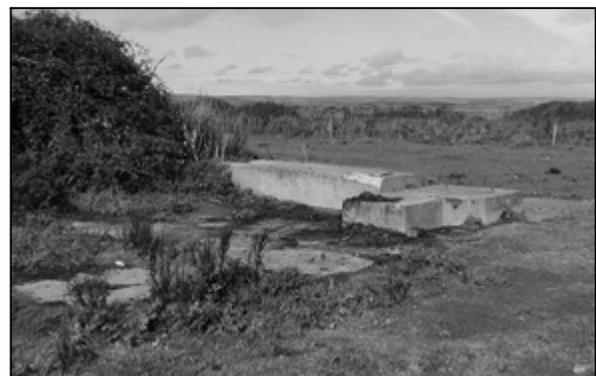
A plinth possibly for a generator.

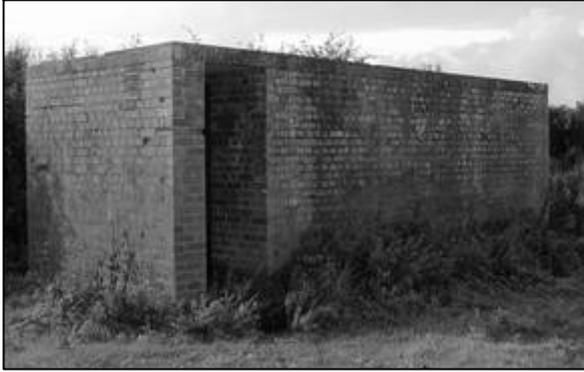
A shelter.

Nearby are a small brick shelter and another brick hut of unknown purpose.

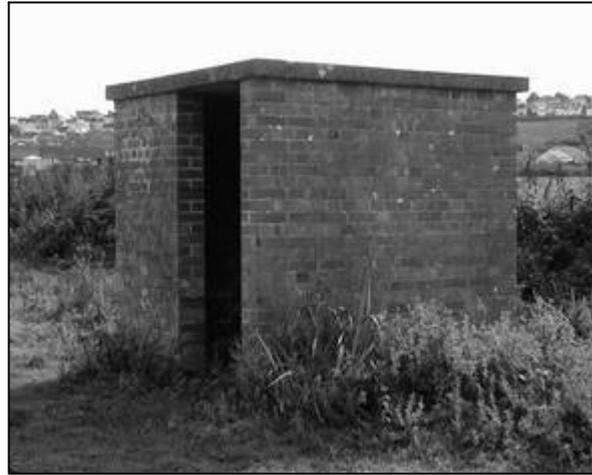
A brick hut of unknown purpose.

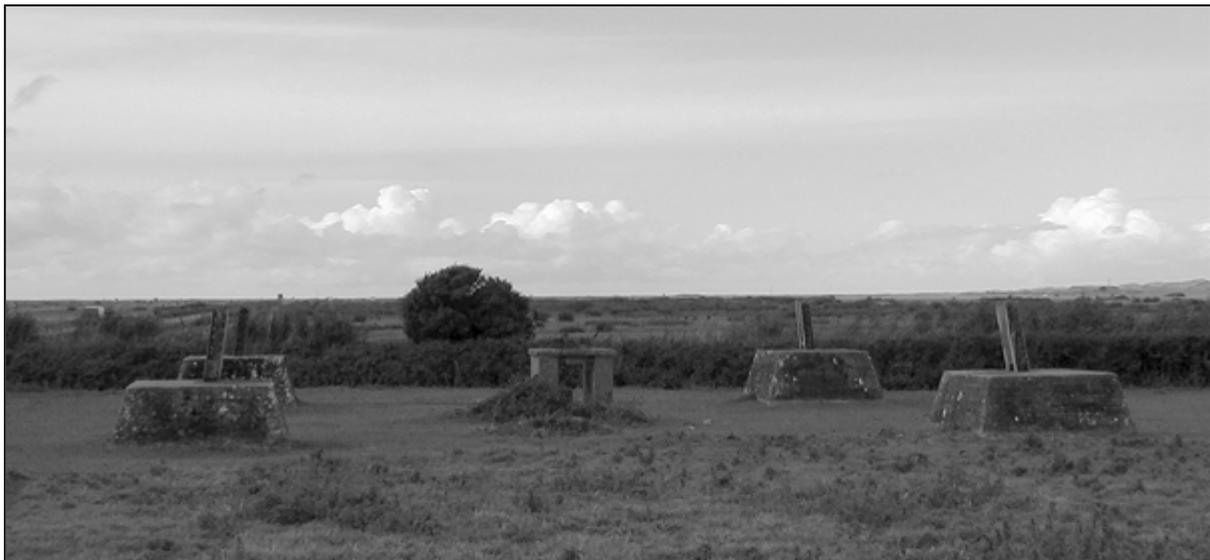
The four concrete bases of a timber receiver tower, together with an aerial cable junction box in the centre.
